**FIVE-YEAR REVIEW REPORT**  
**THIRD FIVE-YEAR REVIEW REPORT**  
**FOR**  
**UNIVERSITY OF MINNESOTA ROSEMOUNT RESEARCH CENTER SITE**  
**ROSEMOUNT**  
**DAKOTA COUNTY**  
**MINNESOTA**

**Prepared by:**  
**United States Environmental Protection Agency**  
**Region 5**  
**Chicago, Illinois**

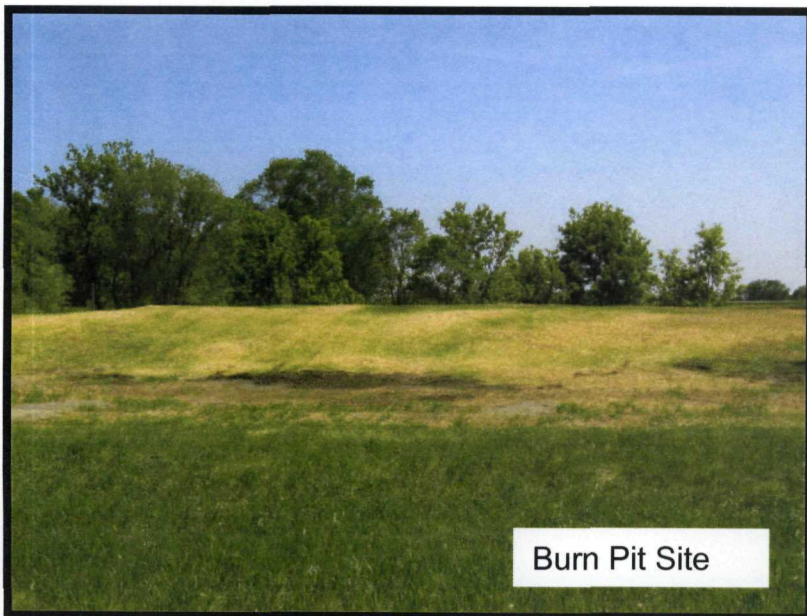
Burn Pit Site

The Burn Pit subsite is a cap over an area where the University burned laboratory chemicals. The clay cap was mowed and there were no signs of erosion. Some minor deterioration of the surface of the cap had recently been repaired. The boundaries of the subsite were generally marked by fence posts from a fence which had previously enclosed the burn pit. No deficiencies were observed for this subsite. While inspecting the Burn Pit subsite, Dave Douglas of the MPCA indicated that there may have been a smaller pit in this area where chemicals had also been burned or disposed of. Mr. Douglas asked Mr. Girtz of the University of Minnesota whether he knew where this area was. Since Mr. Girtz was not actively involved with the site during the investigation stage, he was not sure where this area would have been. See Section VII., Question C of this review for further discussion on this matter.

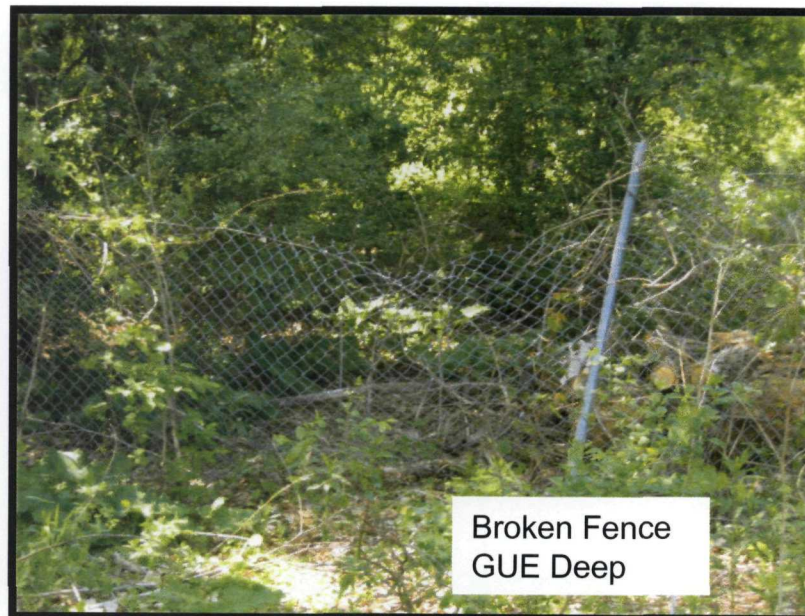
The remedial action for the GUE Deep subsite consists of a fenced area where soils contaminated with 10-25 ppm PCBs were consolidated. The PCB contaminated soils are covered with 16 inches of clean soil. The GUE Deep subsite was found to be undisturbed, however, the fence was damaged in two places near a wooded area adjacent to the fence. While access appeared unlikely in these areas, the fence should still be repaired. The warning signs on the fence which read "Danger Unauthorized Personnel Keep Out" were faded. The signs should be replaced and the new signs should also specifically indicate that hazardous wastes are present.

Broken Fence  
GUE Deep

In general, the inspection found that the remedial actions at the site remain protective and that there are not any activities that would be in conflict with the site restrictions contained in the institutional controls. However, the following actions discussed above need to be performed: 1.) The boundaries of the GUE Shallow, PE and UST subsites should be marked. 2.) All abandoned monitoring wells should be evaluated to assure the wells were abandoned in accordance with the Minnesota Department of Health well code. 3.) The damaged areas of the GUE Deep fence need to be prepared. 4.) New signs with hazardous waste warning language should be placed on the GUE Deep fence.

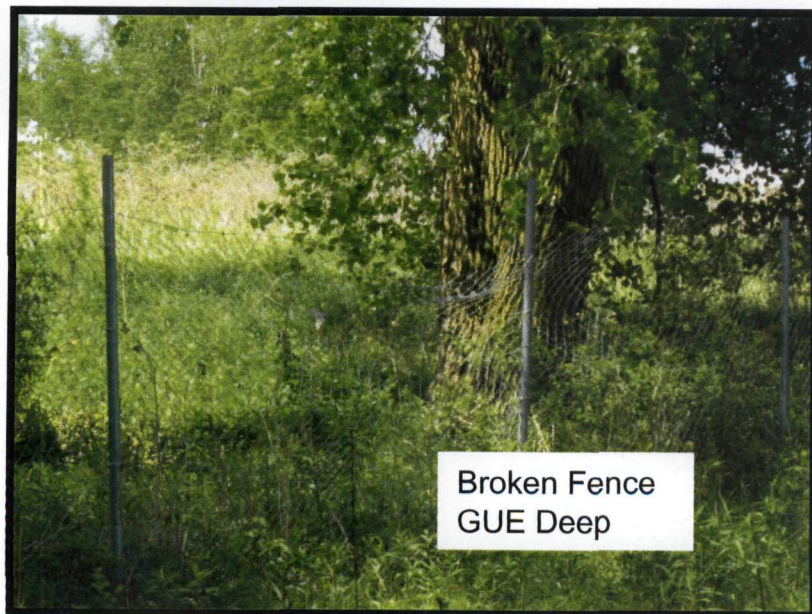
Broken Fence  
GUE Deep

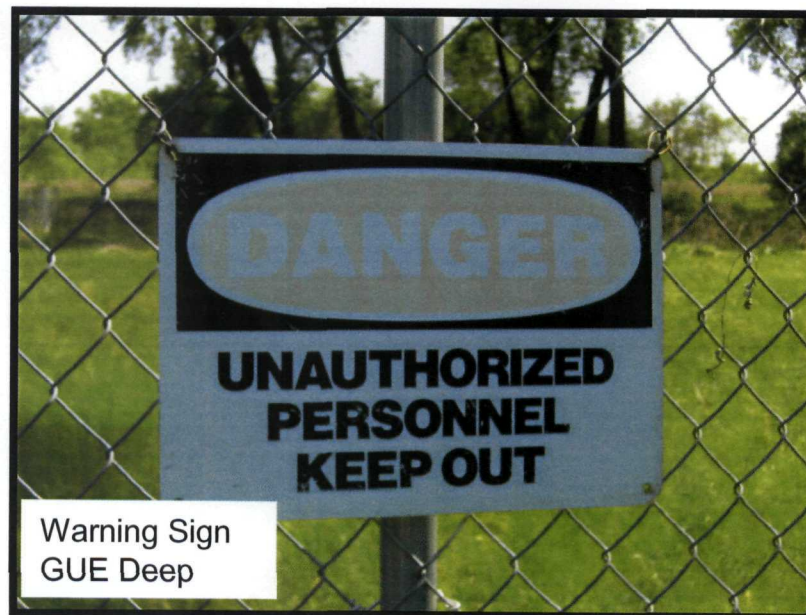
Warning Sign  
GUE Deep

\*\* 1.) The boundaries of the GUE Shallow, PE and UST subsites should be marked. 2.) All abandoned monitoring wells should be evaluated to assure the wells were abandoned in accordance with the Minnesota Department of Health well code. 3.) The damaged areas of the GUE Deep fence need to be prepared. 4.) New signs with hazardous waste warning language. should be placed on the GUE Deep fence.
